## Mark Twain ES Crosswalk Wait Areas (off-campus and/or on-campus)

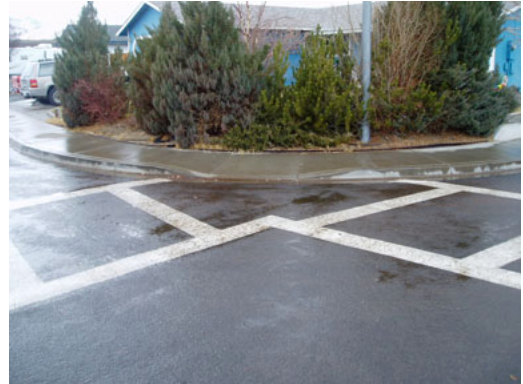
At both ends of the crosswalk of Carriage Crest Dr and Mountain Park Dr, there are insufficient wait areas for students waiting to be crossed by the adult school crossing guard. This encourages students to spill into the street while waiting, and pressures the crossing guard into faster crossing rather than being able to wait for gaps in traffic. The wait area on the west side is further constrained by vegetation on private property and a low retaining wall.

At the west end of the crosswalk, increasing the wait area would require either bulb-outs (curb extensions) or creation of a wait area on private property through negotiation or purchase. Carriage Crest Dr is a designated alternate bicycle route on the Carson City Bicycle Map, though it is not striped or signed, and Mountain Park Dr has been recognized less formally as a bicycle route, so consideration of bulb-outs needs to consider bicycle use since making things safety for student pedestrians by making them less safe for student bicyclists makes no sense. At 40 feet, Carriage Crest could offer two travel lanes and three of four bicycle or parking lanes, but not full facilities.

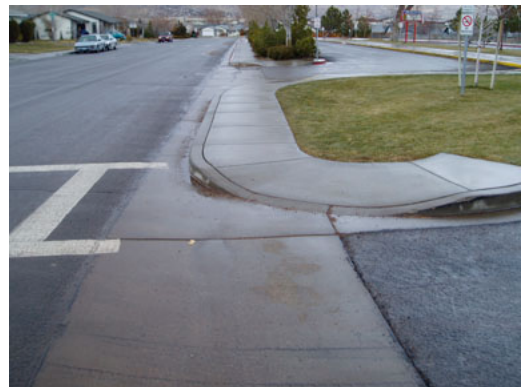
At the east end of the crosswalk, and increased wait area is need because the wait area is immediately between the bus lane entry and the drop-off/pick-up lane entry, with its high traffic flow. Though there is some grass at this location for wait area spill over, wet or snowy weather precludes its use. It is not known at this time whether the potential wait area is in the public right of way or on school district property, so that will need to be clarified. Simply widening this sidewalk area to eight feet would provide a sufficient wait area and create more appealing entry to the campus for student pedestrians.

Apart from property considerations, a wait area of an additional 40 square feet at each end should be sufficient to handle the current load of about 60 students crossing morning and afternoon, as well as an increase through the safe route program. Though safe routes have not yet been defined for Mark Twain, Mountain Park Dr would clearly be a primary safe route, along both sides of the street, so the northwest corner of the intersection and the two crosswalks here, is a key component of the safe routes.
